by Jack Hess

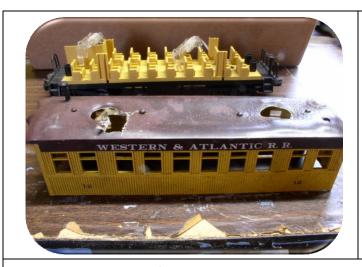
Here is the car as I got it from eBay. I unscrewed the body and began cutting away the roof. Top is completely ruined and so are the end windows on each side on one end.

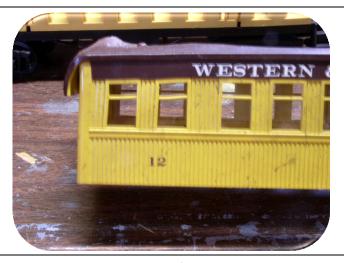
Here is the body after roof has been cut and filed off, and the melted body end cut out.

This end is slightly melted and may need the curve reconstructed.
